DATE:	3SEP2024	BULLETIN #	RL-09.03.2024	REVISION:	1
KIT #:	66-21300 66-21320	PART #:	67-21350UCAL 67-21350UCAR	QUANTITY:	1,170
BRAND:	READYLIFT	DESCRIPTION:	RL 3" FRONT LIFT FORD F-150 TREMOR		
P/N HARMS CLASIFICACION	X 1 (Safety Critical) <input type="checkbox"/> 2 (Moderate) <input type="checkbox"/> 3 (Minor)				
INCIDENT CLASIFICACION	X 1 (Safety Critical) <input type="checkbox"/> 2 (Moderate) <input type="checkbox"/> 3 (Minor)				
DESCRIPTION OF PROBLEM:	Some customers may experience damage to the ball joint housing as a result of extreme driving.

SECTION 4 – VISUAL REPRESENTATION OF THE FIX

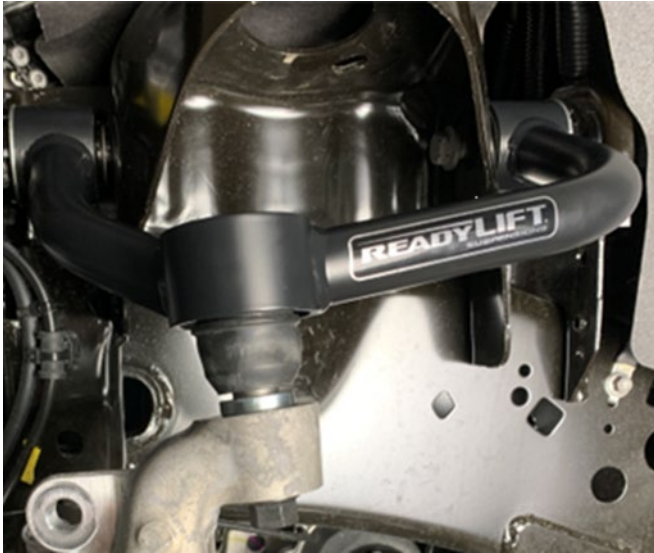
Before TSB

SUSPECT ARMS DO NOT HAVE CAPS OR SIDE-SPECIFIC DECALS

SUGGESTED SOLUTION:	ReadyLIFT will provide upgraded replacement parts to customer at no charge.
PARTS:	67-21640UCAL – RL UCA ASSM, LFT (QTY. 1) 67-21640UCAR – RL UCA ASSM, RHT (QTY. 1) 90-60801 - UCA WSHR M12 TAPERED (QTY. 2) 90-60835 - HWPK 1-1/4 ADEL CLAMP (QTY. 2)
TEST:	Engineering has performed testing to assure upgraded upper control arm assemblies perform as designed under extreme conditions.

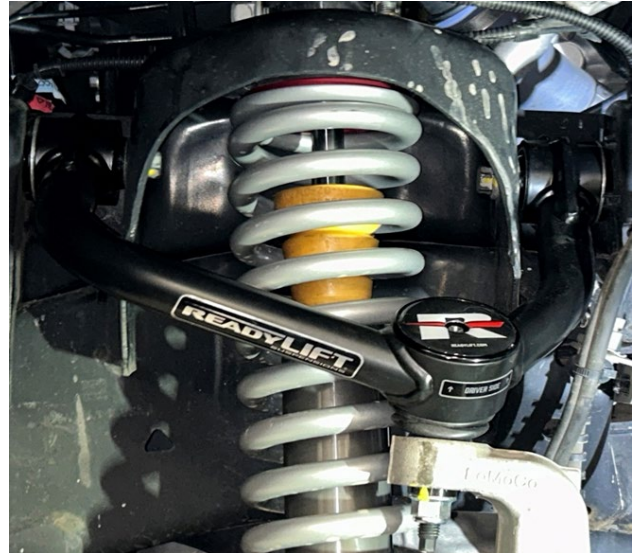
After TSB

UPGRADED ARMS HAVE BALL JOINT CAPS AND SIDE-SPECIFIC DECALS
